Građevinski materijali i konstrukcije Building Materials and Structures

Technical paper

Kula Belgrade - Part 2 - Specifics of construction of Kula structure

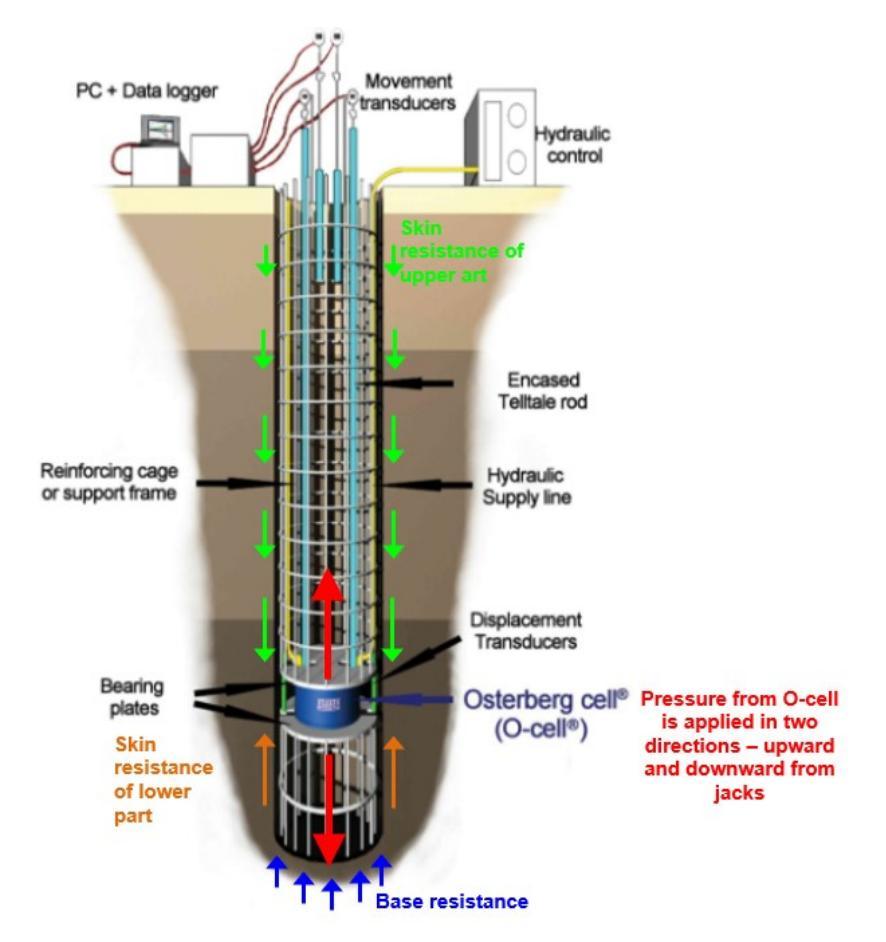
Figure 2. Illustration of principle of O-cell test - Downloaded from <u>http://www.loadtest.com/services/ocell.htm</u>) - comments in colored text were added by Author

The main advantage of this method is that by the installation of a hydraulic jack in the body of the pile, the parts above and below the jack are in balance with each other, so it is not necessary to make reactive piles and a structure for load transfer.

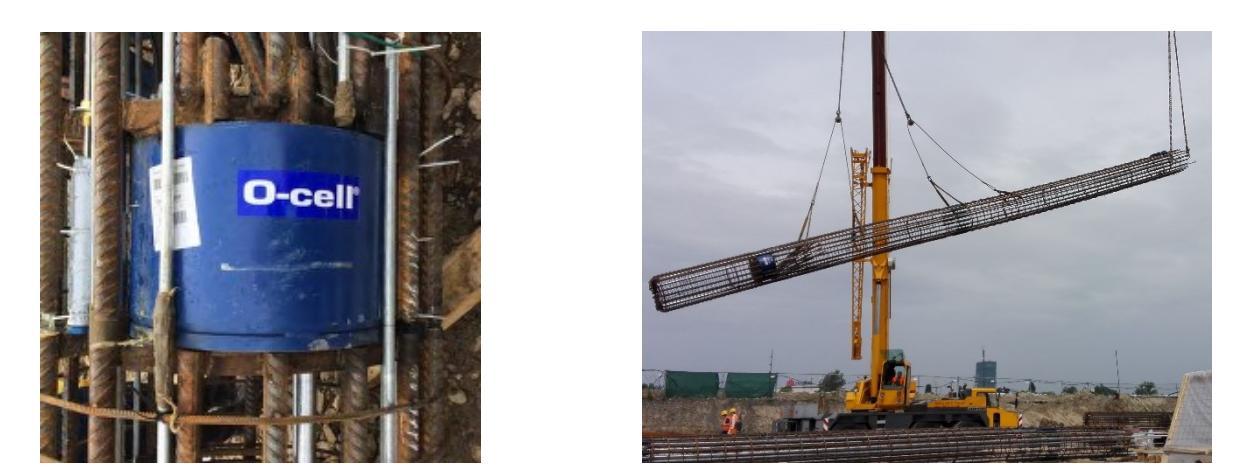
Figure 3. O-cell installed into the pile rebar cage (left) and insertion of rebar cage with O-cell into the borehole (right)

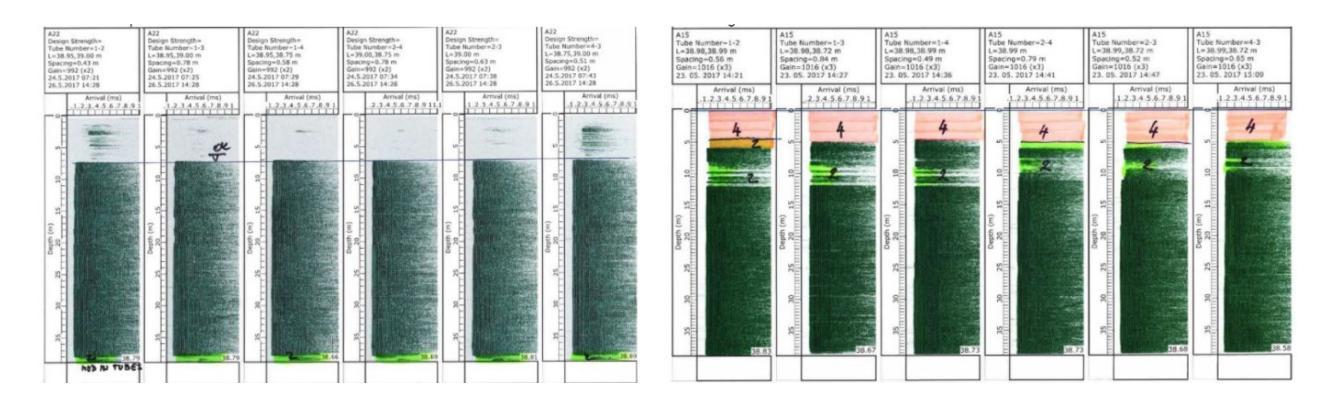
Figure 5. CSL testing records –for a pile withcorrect record (left) and a pile with a loss of signal at the top of the pile (right) – taken from SLP d.o.o. Ljubljana, report: CHA053-05B-2016 Beograd Waterfront Plot 19.1, August 2017.

covering the most of the cross section of the pile. 100% of piles \emptyset = 1200mm and 20% of piles \emptyset = 1000mm were tested. Values in the range of 2700-3300 m/s have been adopted for the minimum acceptable speeds of the ultrasonic wave. On the most of the piles, recorded average speeds were in the range of 3800-3900m/s, which was a very good result, while on 5 piles there was a loss of signal at the top, and on one pile a speed of 3200m/s was measured, at a depth of 25-30m (Ref. [6]). According to the interpretation of the results by the company CSL, the potential reason for such a result was the separation of embedded PVC pipes

from the concrete of the piles. In order to prove this, coring was conducted on all 6 piles, with worse results. Based on the visual inspection of the cores, it was determined that the piles had integrity, and based on the breaking of the cubes conducted in the IMK laboratory at the Faculty of Civil Engineering in Belgrade, it was shown that concrete also had sufficient strength.

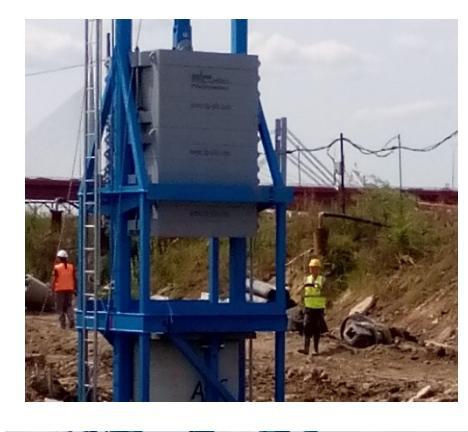
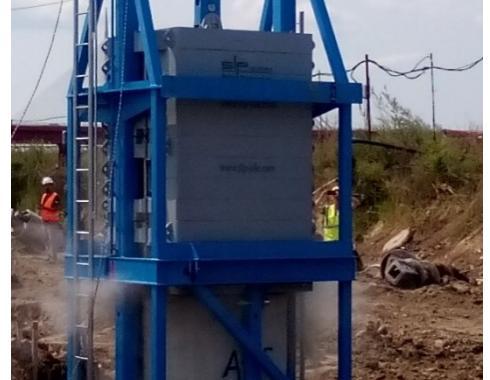
Figure 6. Testing by 42t falling weight from the elevation of 0.3 to 1.5m

The first part of the test measures the dilatation and acceleration of the shock wave caused by the fall of the weight and the wave bounced off the base, which are converted into wave force and speed and displayed on a graph as a function of time. Then Numerical CAPWAP analysis, which uses the equations of wave motion, determines the static bearing capacity of the pile at the base and shaft.

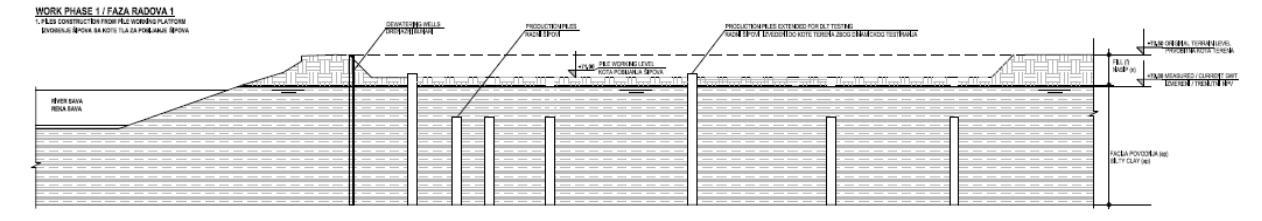
Figure 7. Illustration of the execution of piles form the working platform

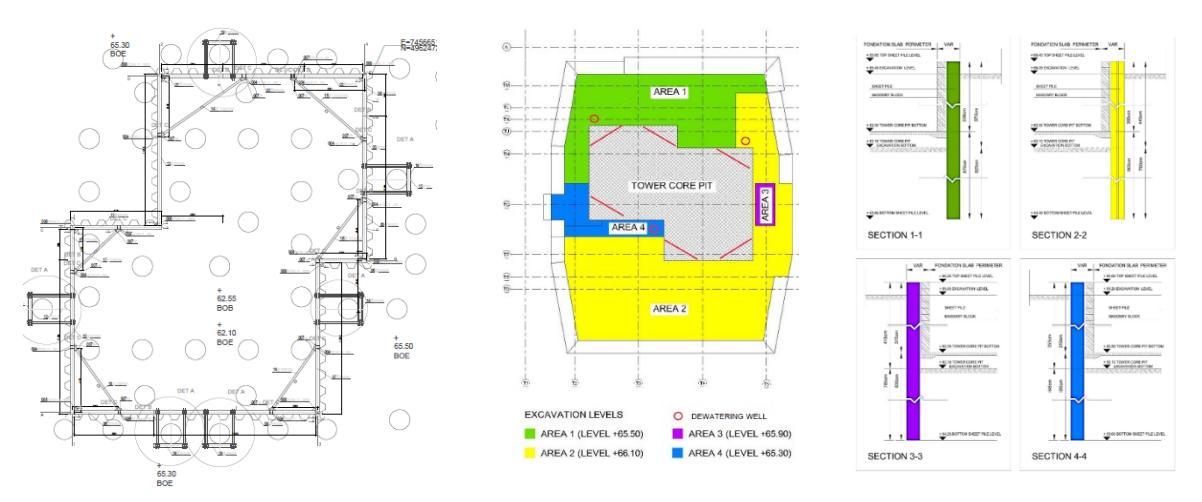
Figure 8. Layout of sheet piling with bracing structure (left), plan with the location of 3 additional dewatering wells (middle) and characteristic vertical sections (right) – taken from RS_BW_P19.1_C_025_PZM_MST_0003_Rev.01_Site Specific Method Statement for Installation of Sheet Piles around Tower Lift Pit

Additional excavations had to be made in the zone of the 4m deep elevator pits, where the final excavation level was 62.1MASL. The vertical excavations were conducted under protection by Larsen sheet piling, which was braced in the corners of the pit by the horizontal steel struts, and on the mid of the section, they were fixed to the piles.

Drainage of this zone was performed by a combination of dewatering wells in the embankment (preserved from UXO works) and three wells added in close proximity of the elevator pit, as well as submersible pumps used for surface waters.

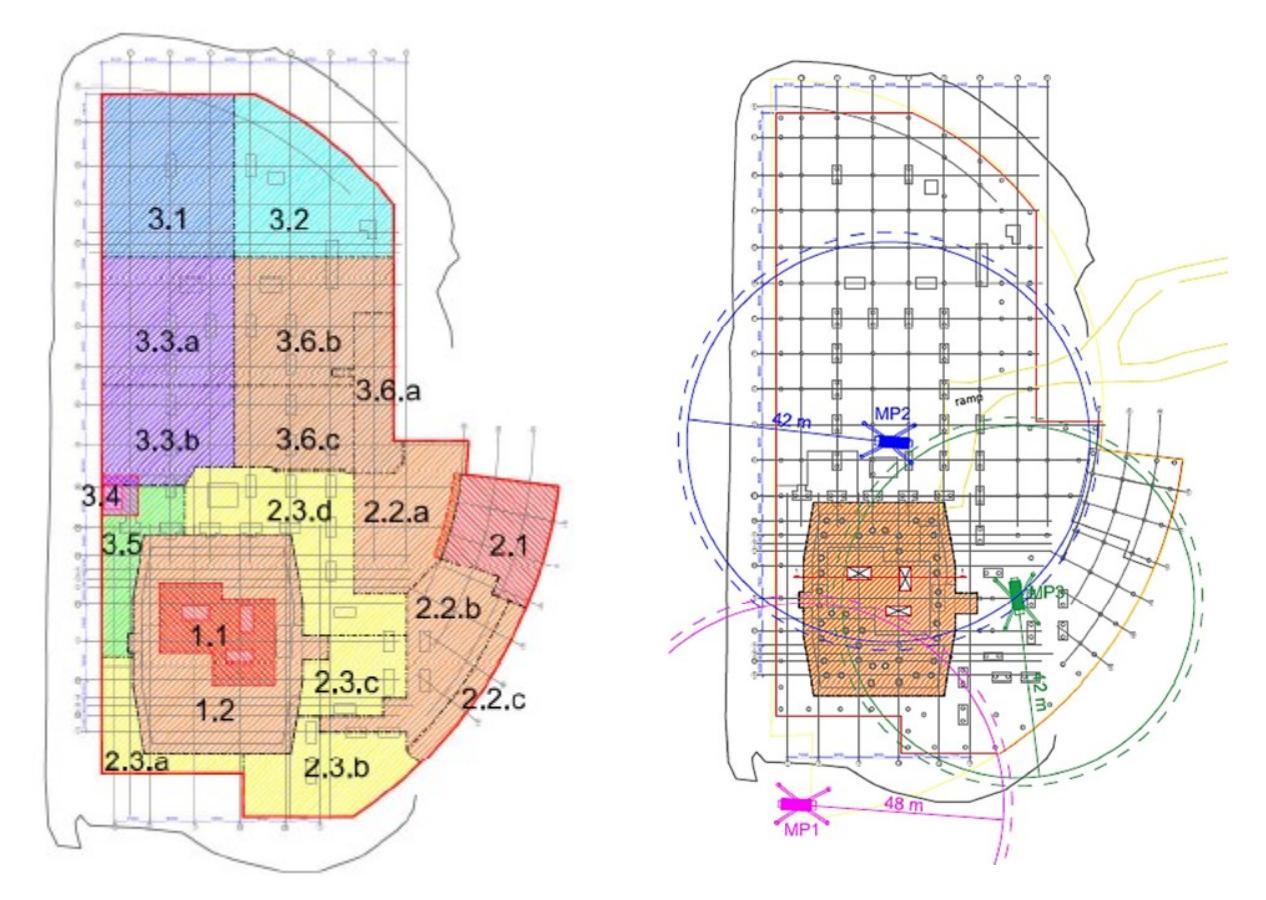
Figure 9. Plan of pours for Kula raft (left) andplan with location of concrete pumps for the pour under the tower (right) – taken from RS_BW_P19.1_C_025_PZM_MST_0006_Rev.02_Site-Specific Method Statement for Raft pouring

The foundation slab, with a total volume of 14000m³, was concreted in the multiple pours shown in the picture below. Parts outside the tower zone are divided into more than ten parts.

Part of the slab in the tower zone was divided vertically in two pours (1.1 and 1.2 in the above figure). The deeper one (1.1) was located in the zone of elevator pits. It was 2.8 m thick, about $400m^2$ in plan with a volume of $1150m^3$ and was cast the first.

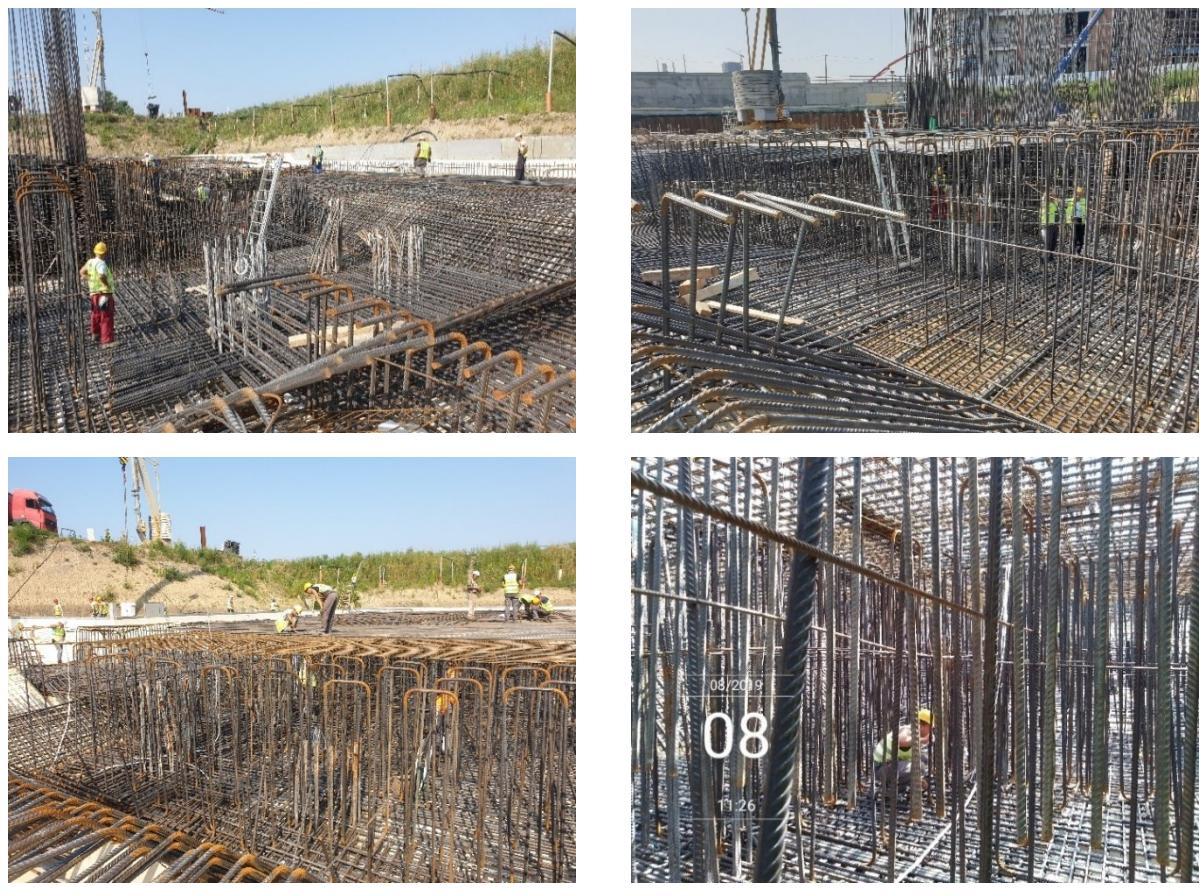
Figure 10. Reinforcement works on pour 1.2 - raft pour under the tower

Such configuration imposed significant challenges both in terms of reinforcement and concrete works. In the former case, the Contractor had to provide stability of rebar cage. This was achieved by the adoption of two chairs Φ 32 with 2 legs per square meter. They were horizontally interconnected and braced by inclined bars along the perimeter of the zone.

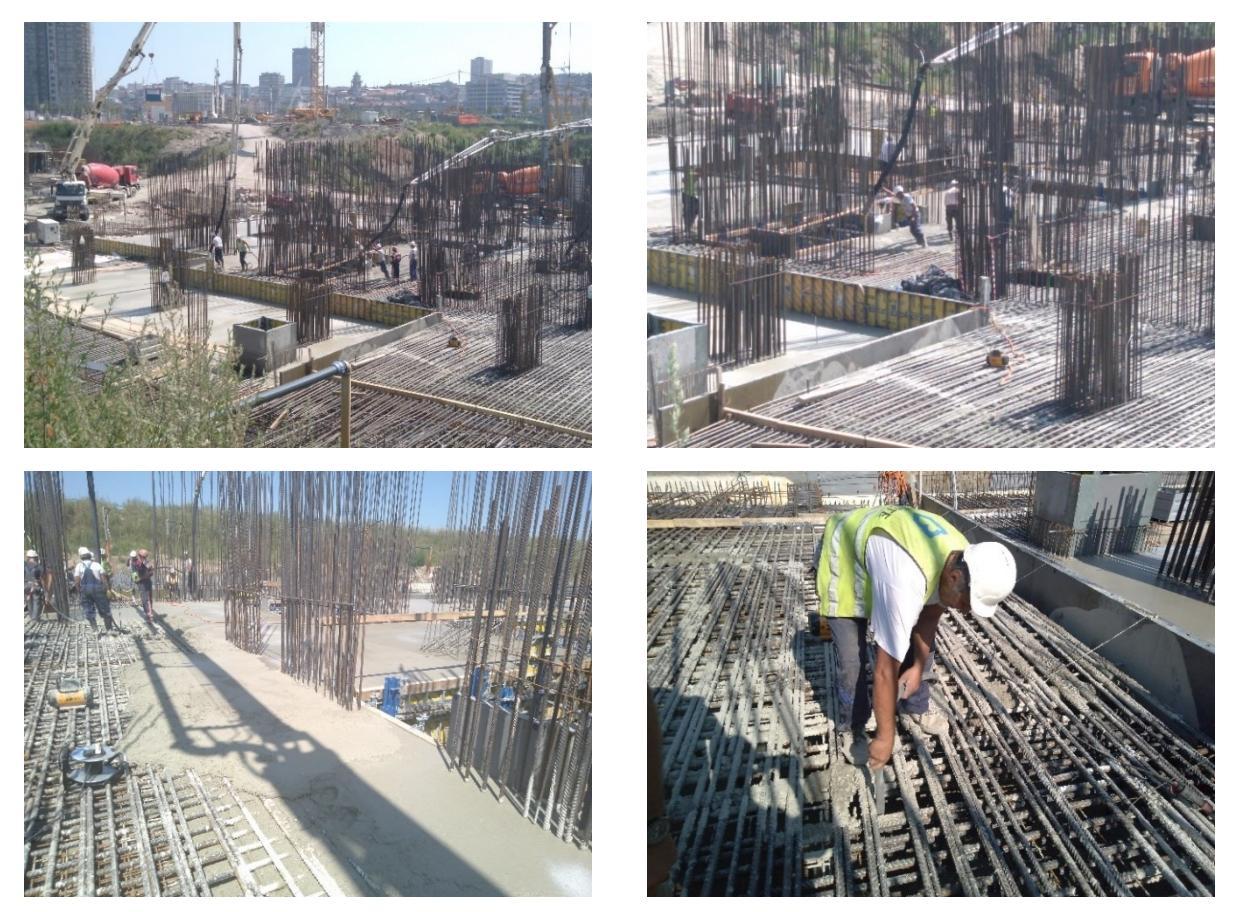
Figure 11. Casting of raft pour 1.2 under the tower

In terms of concrete works, the volume of 4750m³ may be regarded as one of the biggest concrete in Belgrade, ever. Decision to cast it in one turn was based on two reasons division into smaller parts was basically impractical and division by height was discarded as to avoid the formation of cold joints. This large amount of concrete required careful selection of the components of the concrete mix. This primarily refers to the type of cement - CEM III / B (cement with over 65% slag) was used, which reduced the risk of thermal cracks in mass concrete. The reduced mobility / workability of concrete with such cement was overcome by the use of hyperplasticizers. The large concrete casting area, as well as the logistics of concrete supply from several factories, demanded the provision of a significant time reserve, which was achieved by using retarder admixtures that delayed the starting of the setting of concrete for not less than 16 hours.

This enabled concreting in horizontal layers 40-45 cm thick (in deeper parts with a smaller working area) up to 20 cm (in the upper parts) and to start the casting of the next layer prior to the setting of the previous layer. Adjacent vertical layers were interconnected by vibration.

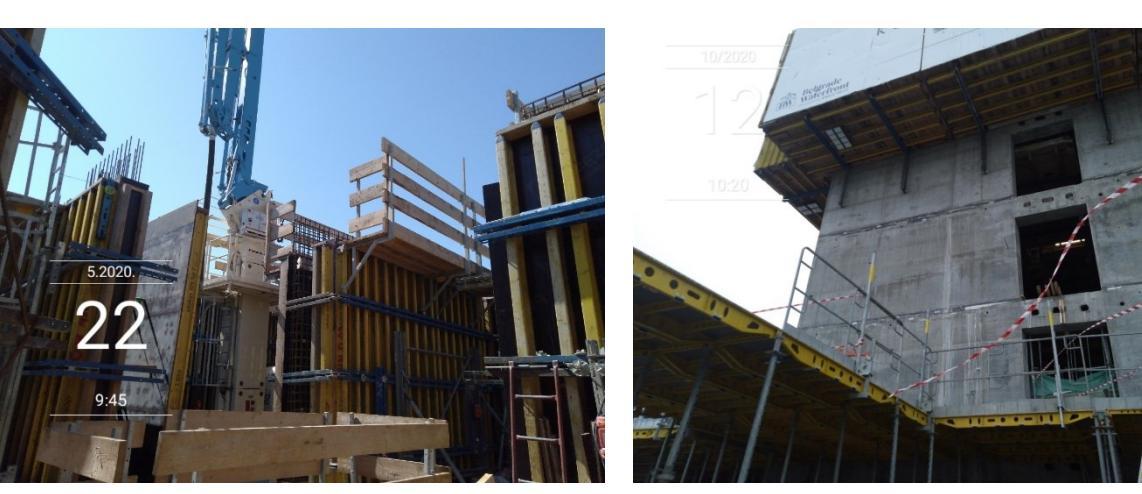
Figure 12. Construction of core walls in jump form

Kula's core walls were constructed in jump form. Doka's automatic climbing formwork SKE 50 plus was used to jump / climb the core with hydraulic jacks. They were cast in Doka's shuttering system Top 50, which was constructed in height of 4.1m to allow for concreting in one turn of all typical storeys with a height of 3.45m and most of the non-typical storeys. In the case of storeys with a height greater than 4.1m such as GF, Level 2, 11, 12, 19 and 39 to 42, they were cast in two steps. In total, there were 52 castings and 57 climbing steps from B1 level up to the top roof to achieve the cores, starting from level -7.97 and reaching a level of +168m (relative to Architectural zero level).

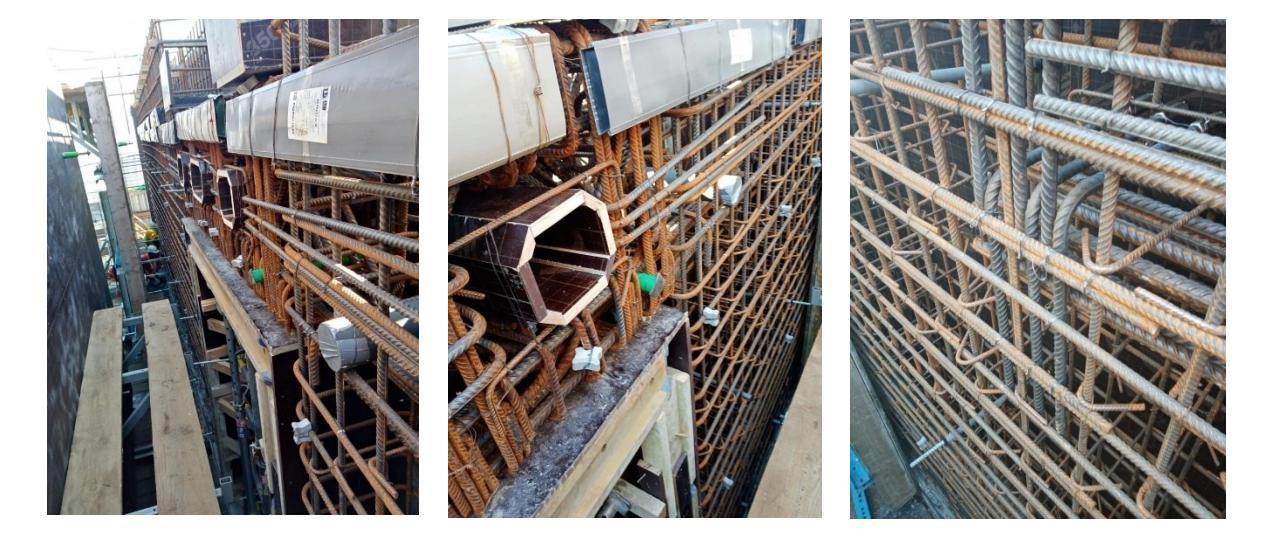
Figure 13. Link beam reinforcement with Bindax pullout boxes on top - installed into wall rebar cage (left and middle) and core wall reinforcement (right)

Reinforcement of wall segments as well as for link beams (described in the 1st part of the article) was prefabricated on the ground, lifted and installed into the shuttering by crane. Horizontal U bars at the wall ends were added. Reinforcement assembly also included bent out elements by Bindax Company. They were to allow connecting of slabs to core walls.

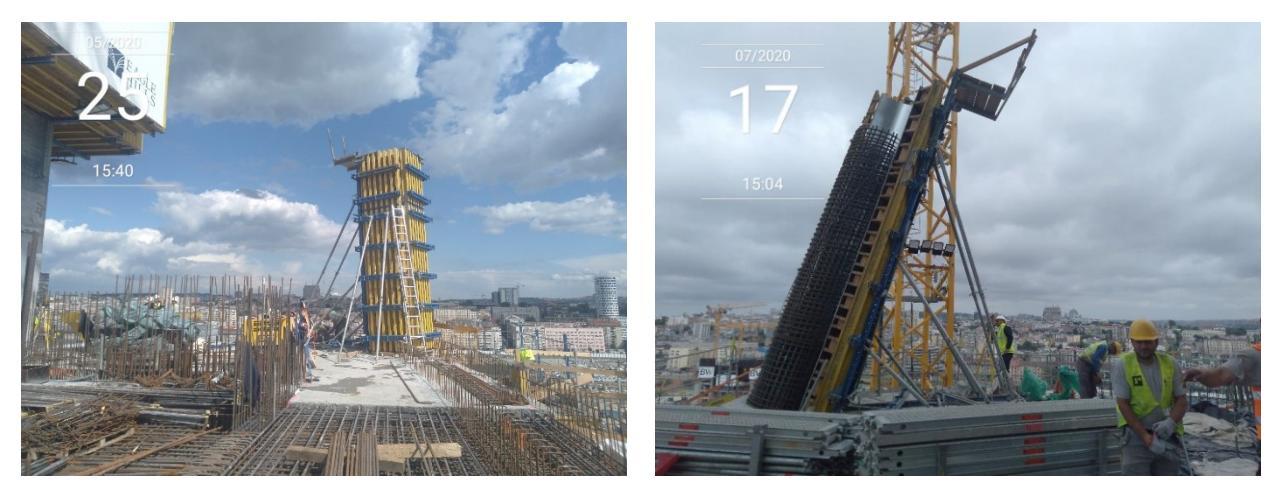
Figure 14. Construction of circular transfer columns Level 12-14 (left) and Level 16-17 (right)

Upon the completion of rebar cage, columns of circular cross-section were made in a circular formwork called DOKATop 50, which consisted of two semi-circular parts connected by bolts. Sloped columns of rectangular cross-section were constructed in the DOKA Framax system. At the point of column branching (Levels 14-15), a joint, outer aluminium shuttering, enclosed both branches, while they were internally divided by a wooden partition.

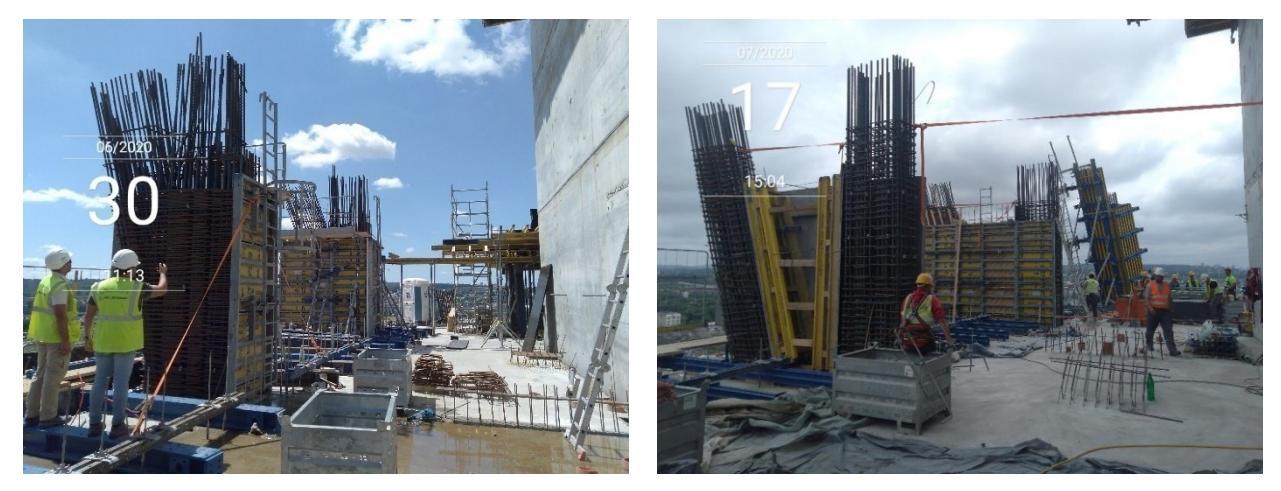
Figure 15. Construction of transfer branching columns Levels 14-15 (left) and Levels 15-16 (right)

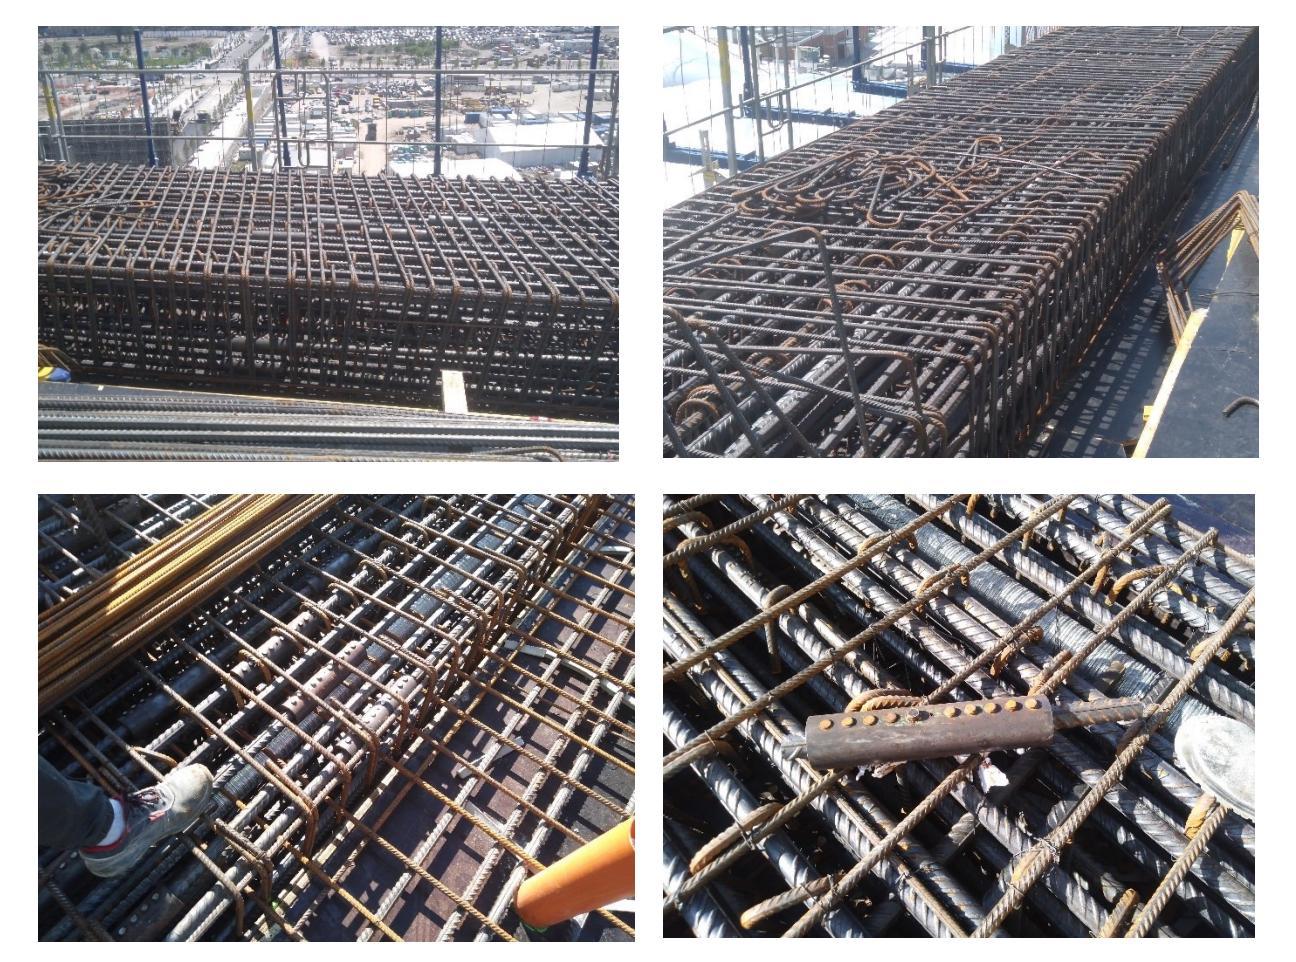
Figure 16. Transfer beams on Level 12 (top row) and on Level 20 (bottom row) – details of coupled bars (bottom left) and discarded coupler (bottom right)

In the case of rebar ties, there were $5\Phi32$ in the top and bottom zone on Levels 12,10 $\Phi32$ in top and bottom zone on Lev14, and all of $\Phi32$ bars on Level 20 that had to be spliced by mechanical couplers. As the Halfen MBT type, popularly called the "crocodile" did not require the turning of bars, it was adopted. Instead, the bars are just inserted into a coupler and fixed to it by bolts, tightened until they snap. In case that any of the bolts did not reach the final position, the coupler was discarded and replaced by a new one.

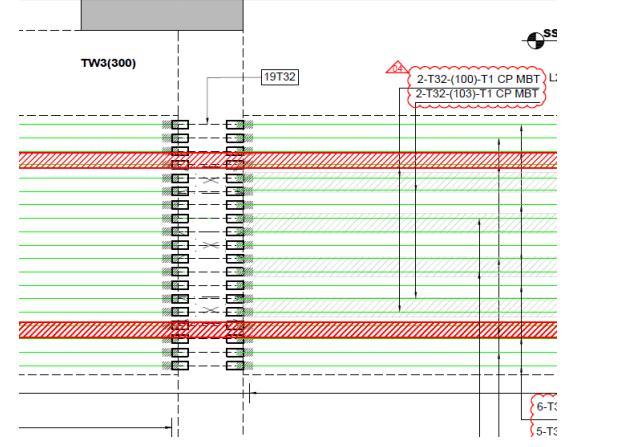
Figure 17. Lenton couplers for Transfer beam on Level 20 at core wall in Contractor's shop drawing (left) and on site (right)

Another type of rebar splicing was adopted at the faces of the core walls where threaded Lenton couplers were used.

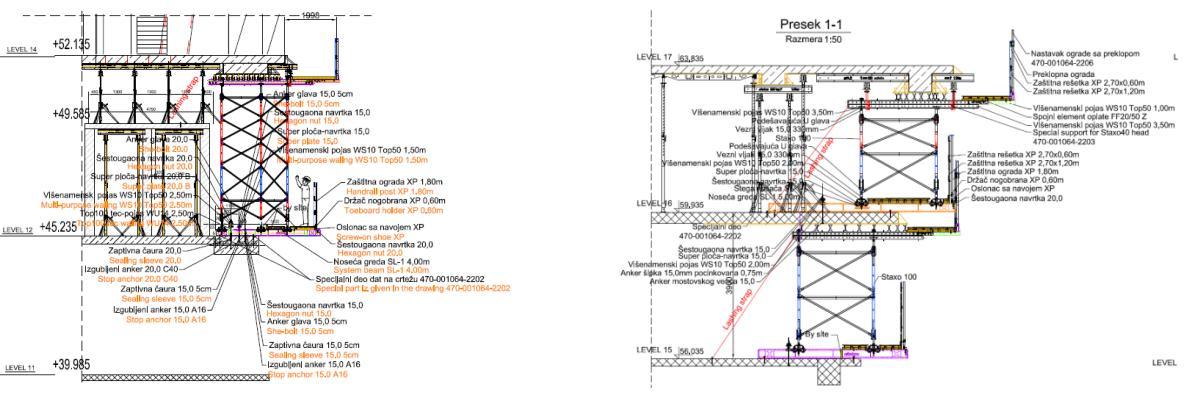
Figure 18. Illustration of extension of slab edges on transfer levels - Levels 12-14 (left) taken from RS_BW_P19.1_C_025_PZM_DDC_0048_Rev.00_Doka Formwork Plans_L12 formwork Platforms supporting L14 Slaband Levels 15-17 (right) – taken from RS_BW_P19.1_C_025_PZM_DDC_0058_Rev.01_Doka_Formwork Plans and Platforms supports for L17

Another specific issue was the geometry of transfer slabs. While the slabs were shrinking from Level 12 to 20 in a North-South direction (direction parallel to the Sava River) they expanded in a perpendicular direction. Accordingly, there was an issue of access and supporting shuttering in the East-West direction because the upper slabs were projecting out of the perimeters of the lower ones. The issue was resolved by the application of Doka Staxo towers that were fixed to the structure by a system of anchors and lashing straps.

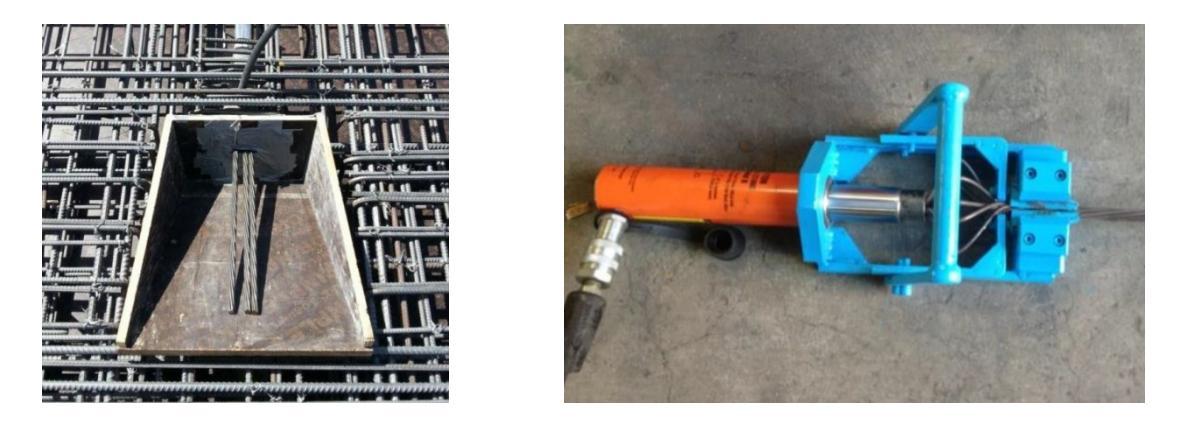
Figure 19. Live end with pan box (left) and formation of onion head dead end (right) (both obtained from Contractor's document Method Statement for Post-tensioning worksRS_BW_P19.1_C_025_PZM_MST_0021_Rev.00_Post Tensioning Works)

The PT system consisted of 12.7mm mono strands. They were inserted by a cable pusher machine into the flat ducts with 3 to 5 slots to form the tendons. A live anchor was mounted at the tendon end at the outer perimeter of the slab, or at the pan box in case it was not designed to reach the slab end. Dead end anchors were formed on site by the onion jack tool and stressing pump. Both ends were supplied by anti-burst spiral reinforcement. Tendon profiling was achieved by fixing the tendons to the plastic chairs at the required height, adopted at approximately 1.0-1.2m spacing, and stapled to the wooden shuttering with a heavy duty stapler to secure their geometry during the concreting.

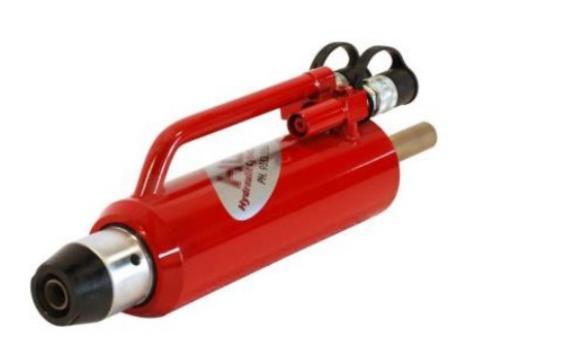
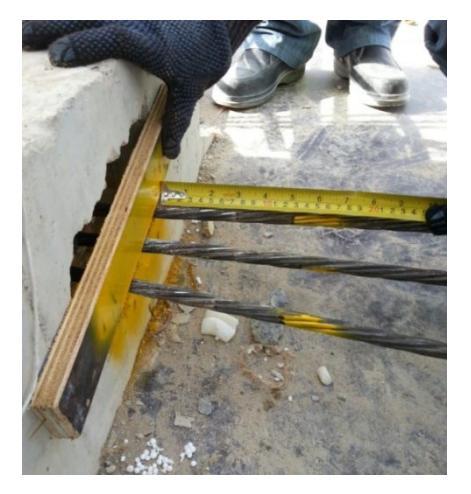
Figure 20. Mono strand stressing jack (left) and measurement of achieved elongations (right) (both obtained from Contractor's document Method Statement for Post-tensioning worksRS_BW_P19.1_C_025_PZM_MST_0021_Rev.00_Post Tensioning Works)

Stressing was conducted in two stages. Stage 1 took place approximately 12 hours after the casting, but not before the concrete cube strength reached 10MPa. It was done to the level of 25% of the total jacking force. The remaining force was applied once the concrete cube strength reached 25MPa (the design concrete grade was C40/50), which was usually less than 48 hours after the casting. The total jacking force was set at 80% of the ultimate tensile strength of the strands, or 1480MPa = 0.8*1860MPa.

Elongations measured during the stressing were submitted for the engineer's approval in a form of a stressing record report, and only after the approval of the Engineer the cutting of strands was conducted.

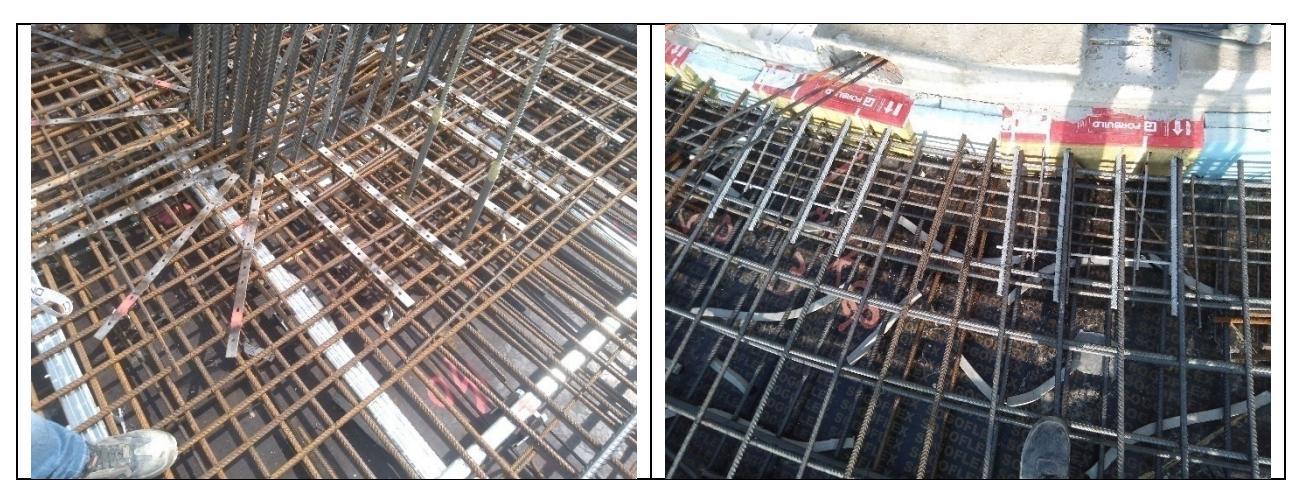
Figure 21. Halfen shear rails with double headed studs (left) and thermal connector at balcony location (right)

As for the reinforcement works, it is interesting to mention that the slab capacity in terms of punching shear was provided by double headed Halfen studs with a 12mm diameter welded to Halfen HDB shear rails, that were inserted into the installed slab reinforcement. Due to the requirements in energy efficiency regulations, the balconies had to be completely thermally insulated from the main slab. This was achieved by thermal connectors made by Forbuild Company. The connector consisted of a central part made of thermal insulation, through which two steel plates were embedded to enable the transfer of shear forces, while the moment action was enabled by straight rebars placed on the top of the section and three high strength bearing blocks placed at the bottom to transfer compression forces.

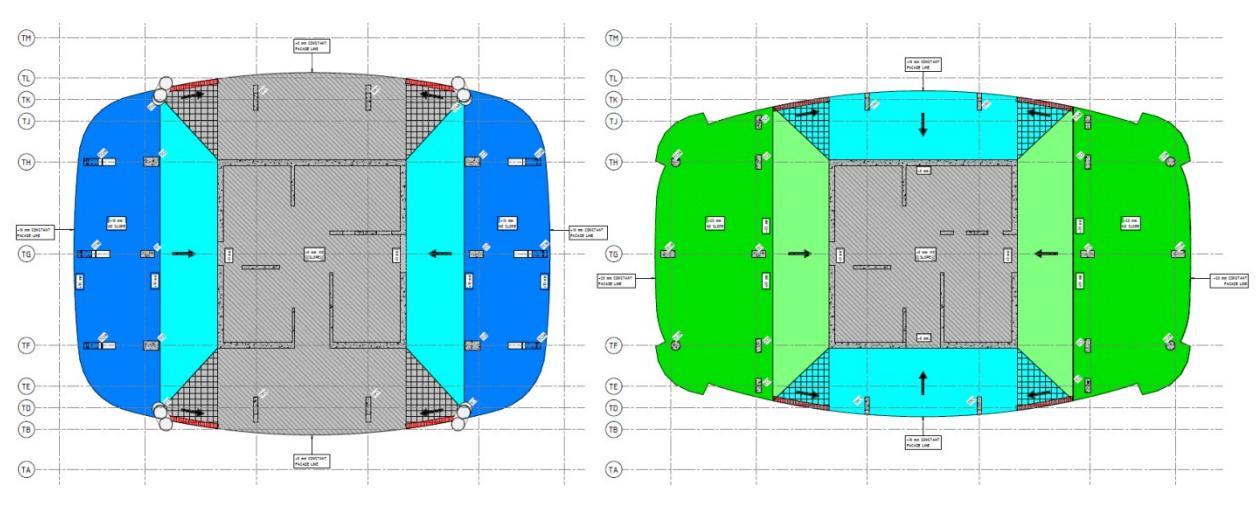
Figure 22. Pre-setting scheme for levels 18,19,20 (left) and 21-40 (right)

In terms of work related to formwork and shuttering, it is worth mentioning that all the slabs above level 11 had to follow pre-setting schemes adopted during the Value Engineering design by which the perimeter of the slab was supposed to be executed higher than the centre of the slab to allow the slab to achieve horizontal geometry once the differential settlements between the core and columns take place over the years of service. Typically, the difference in levels was 10mm up to level 20 (dark blue hatch on below figure), but it was 20mm on residential levels (21–40) (green hatch on below figure).
